Case Vehicle (A): 2000 Ford
 Type: Focus, 3-door hatchback
 Driver: 23-year-old male
 CDC: 02-RPAW-3

Vehicle (B): 1999 Ford
 Type: E-350, passenger van
 Driver: 36-year-old male
 CDC: 99-0000-0

GENERAL VEHICLE DAMAGE AND ESTIMATED CRASH SEVERITIES

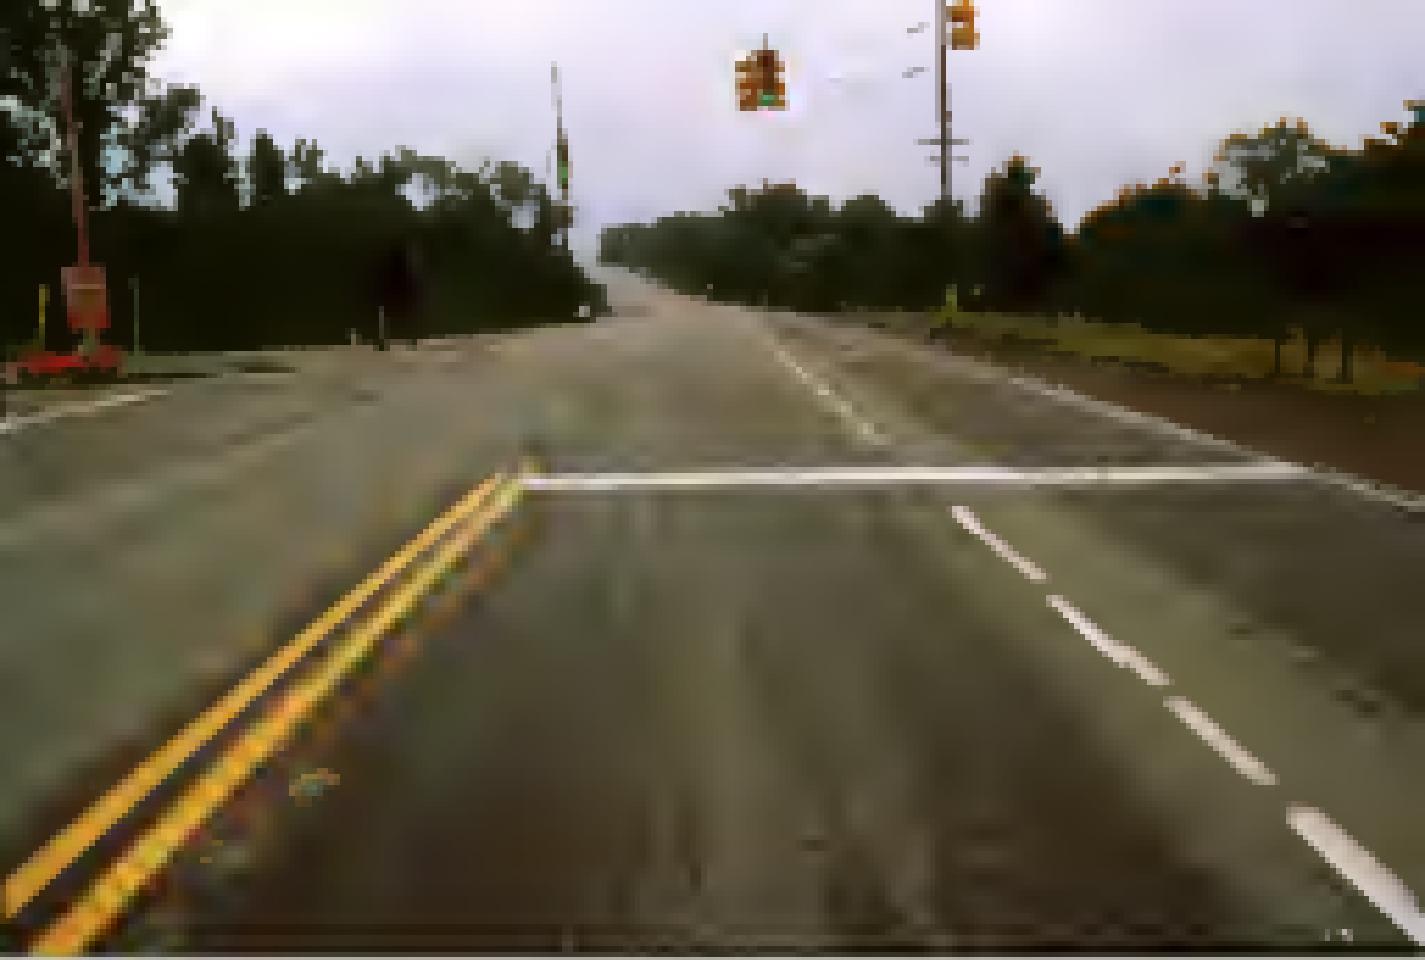
PN 17800 #1

(Slide 1) Case vehicle (A) was traveling south in the inside southbound lane of a straight section of a wet asphalt, three-lane roadway, (slide 2) with a speed limit of 72 kph (45 mph), and was approaching a controlled three-leg intersection, that is the on-ramp to a divided highway. The off-ramp from the divided highway is north of the on-ramp and separated from the on-ramp by a grass median. The intersection of the three-lane roadway and the off-ramp is controlled for traffic exiting the off-ramp. Vehicle (B) was traveling in the single northbound lane, of the three-lane roadway. As vehicle (B) entered the controlled intersection, the driver of case vehicle (A) made a left turn across the path of vehicle (B). Vehicle (B) struck the right side of case vehicle (A) with its front end. The impact caused case vehicle (A) to rotate clockwise, and to move away from vehicle (B). Case vehicle (A) came to rest in the median that separates the on and off ramps. After impact, vehicle (B) rotated clockwise slightly, and came to rest in the mouth of the intersection of the three-lane roadway and the off-ramp.

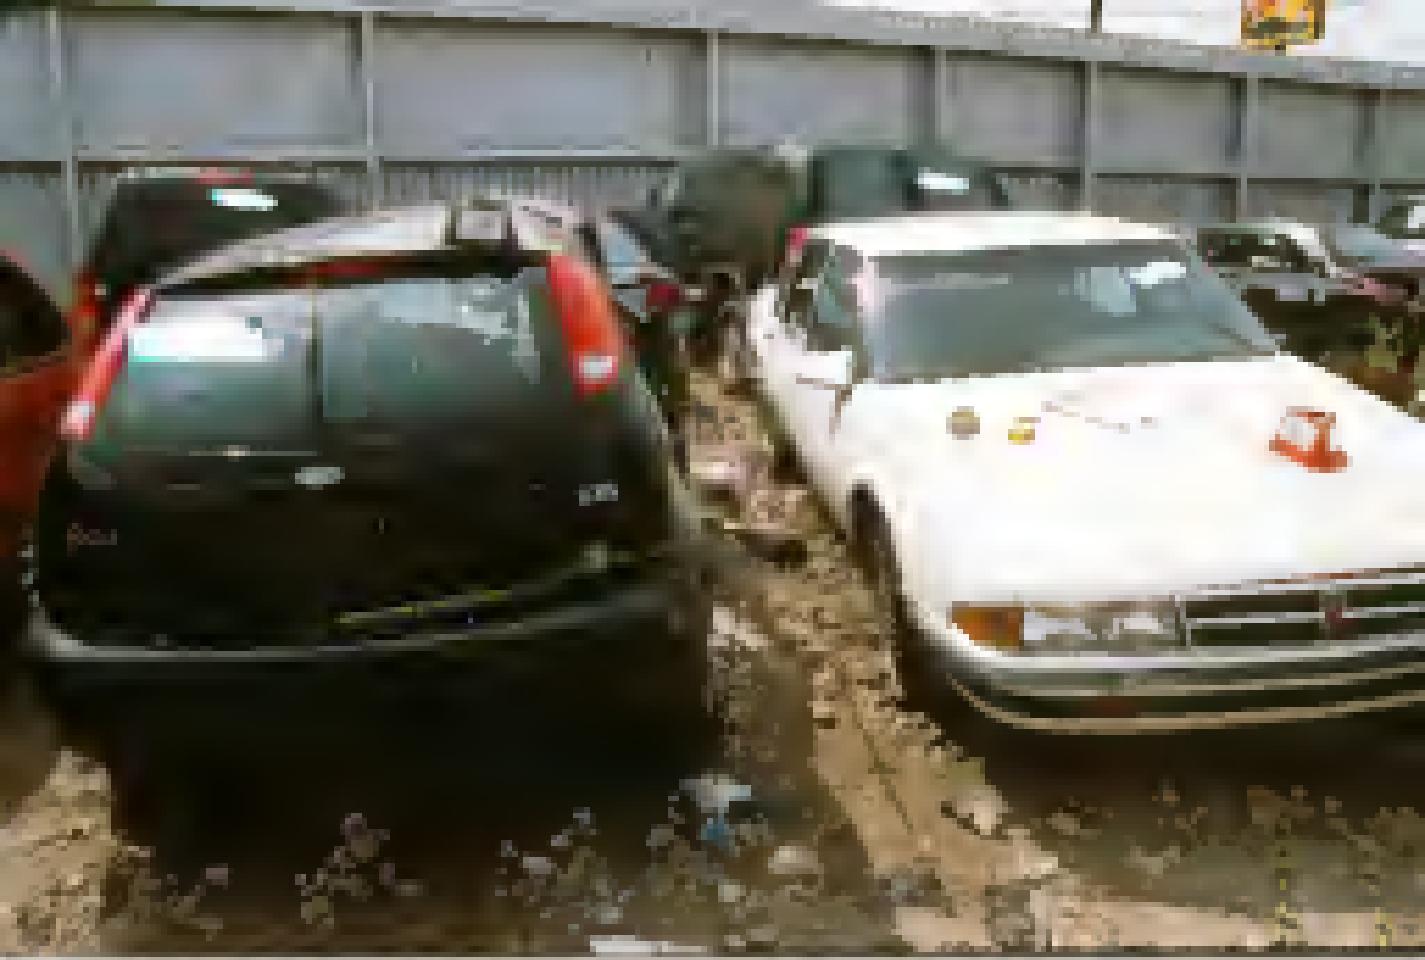
PN 17800 #3

(Slide 3) Damage to case vehicle (A) was severe. The direct-damage length was 246 cm and began 32 cm rearward of the right-front axle. The maximum crush above the sill was 42 cm and occurred 125 cm rearward of the right-front axle. The right wheelbase was reduced 4 cm, and the left wheelbase was unchanged.

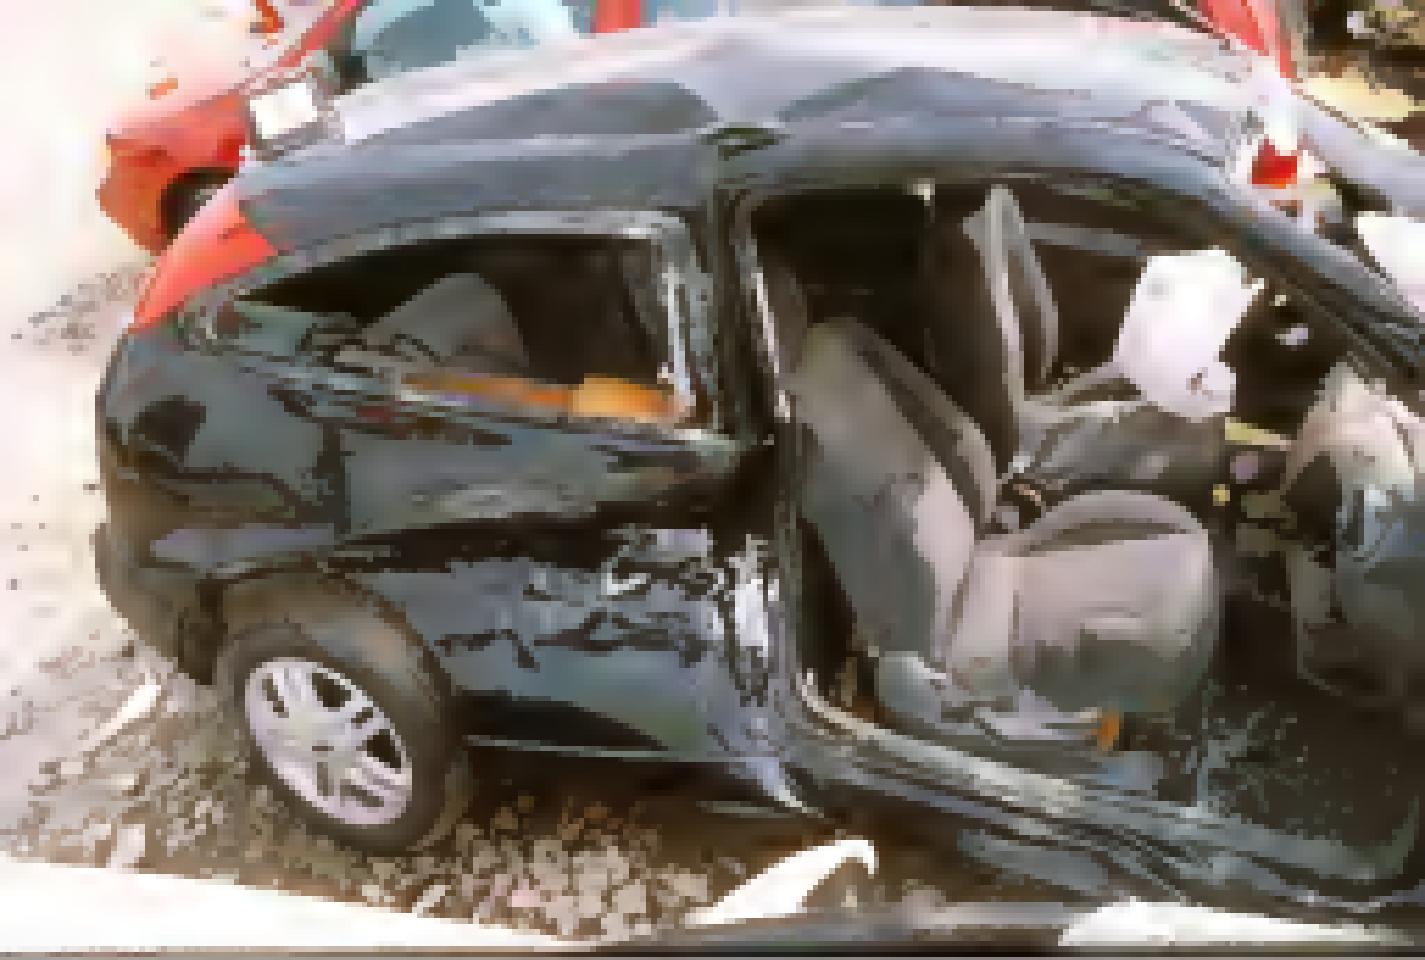
PN 17800 #11

(Slides 10, 11, 12, 13, 14, 15, 16, 17) The upper and lower areas of the right A and B-pillars were deformed and the right roof siderail and the right side of the roof were buckled. This distortion of the greenhouse caused the windshield to crack, but there was no bond separation. Both right-side windows shattered resulting in occupant compartment integrity loss. The right-front door was displaced rearward, causing the latch to jam shut, but it was removed during extrication of the right-front passenger. The other doors remained closed and operational. The right rocker panel was damaged from direct contact by vehicle (B). The right fender and quarter panels were buckled.

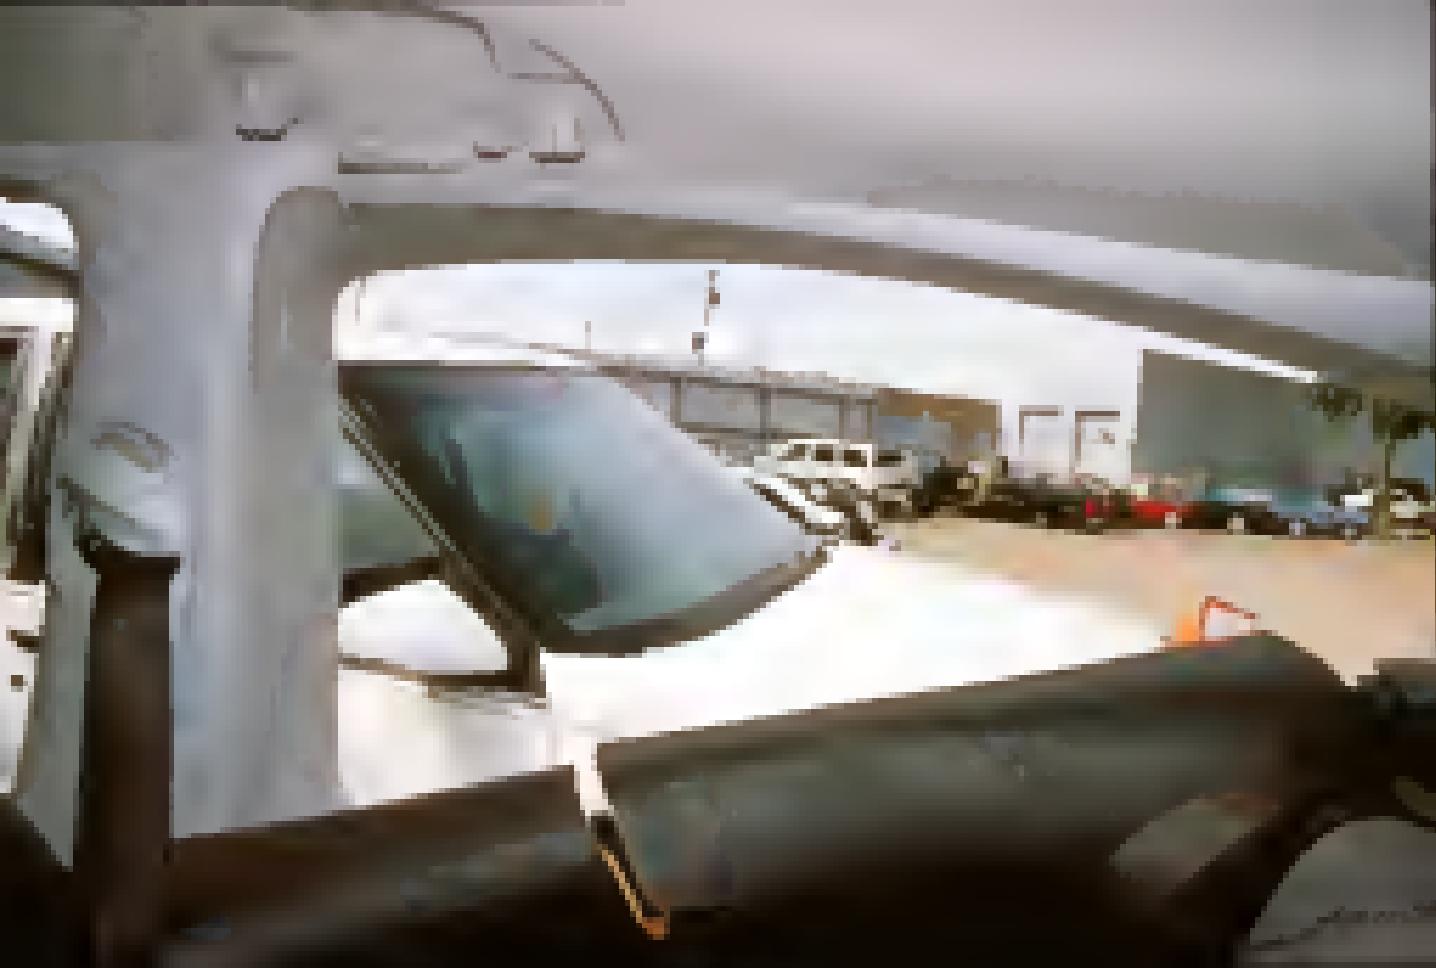
PN 17800 #53

The 6-ft, 1-in, 200-lb, right-rear passenger (slide 53) was not wearing the available three-point belt, as evidenced by the available three-point belt being jammed in a retracted position. (Slides 54, 55) He sustained a fracture to the right hand, probably from contact with the side surface of the vehicle interior.
